United States Department of Agriculture
Forest Service

National Technology & Development Program • 7700—Transportation Mgmt • 1177 1810—SDTDC • December 2012

Decision Analysis Guide for Corrugated Metal Culvert Rehabilitation and Replacement Using Trenchless Technology

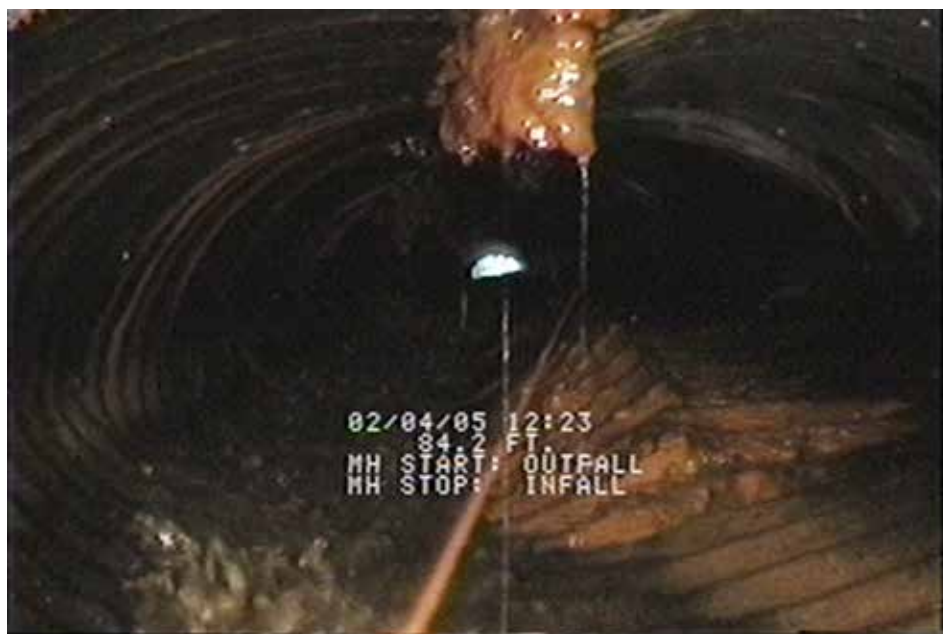
Figure B.8—Inside the culvert looking upstream, 84 feet from the outfall, Road 1924 milepost 0.1. (The orange line is a sewer string used to pull the camera up through the culvert.)

Photos in figures B.7 and B.8 were taken from the closed circuit television footage.

As seen from the closed circuit television images, this culvert has failed. The corrugated steel has buckled on the top, bottom, and both sides. The vertical space on one side is about 8 to 9 inches (on the left in figure B.9), and the vertical space of the opposite side of the pipe is about 4 inches. The top of the culvert is being forced downward by the weight of the roadway embankment, estimated to be about 3,800 pounds per cubic foot. The top has split and minerals are forming as soil is washed into the pipe from above. Note that water is running off the stalactite (figure B.9), indicating that the water table outside the culvert is above the pipe, probably due to streamwater flowing along a porous annular space outside of the pipe. (Note that 2005 was a very dry winter in this area.) The bottom of the corrugated steel is split and buckling upward because of horizontal soil forces and a weak invert. The lateral edges of the steel are creased, and the top and bottom are bending inward around the creases.
